ASIA TURBOMACHINERY & PUMP SYMPOSIUM
SINGAPORE | 22 - 25 FEBRUARY 2016
M A R I N A B A Y S A N D S

Measurements and Analysis of High Machine Vibration: A Case Study of Screw Compressor Rub

Sherif Mekawey
Principal MDS Leader
GE M&C Bently Nevada

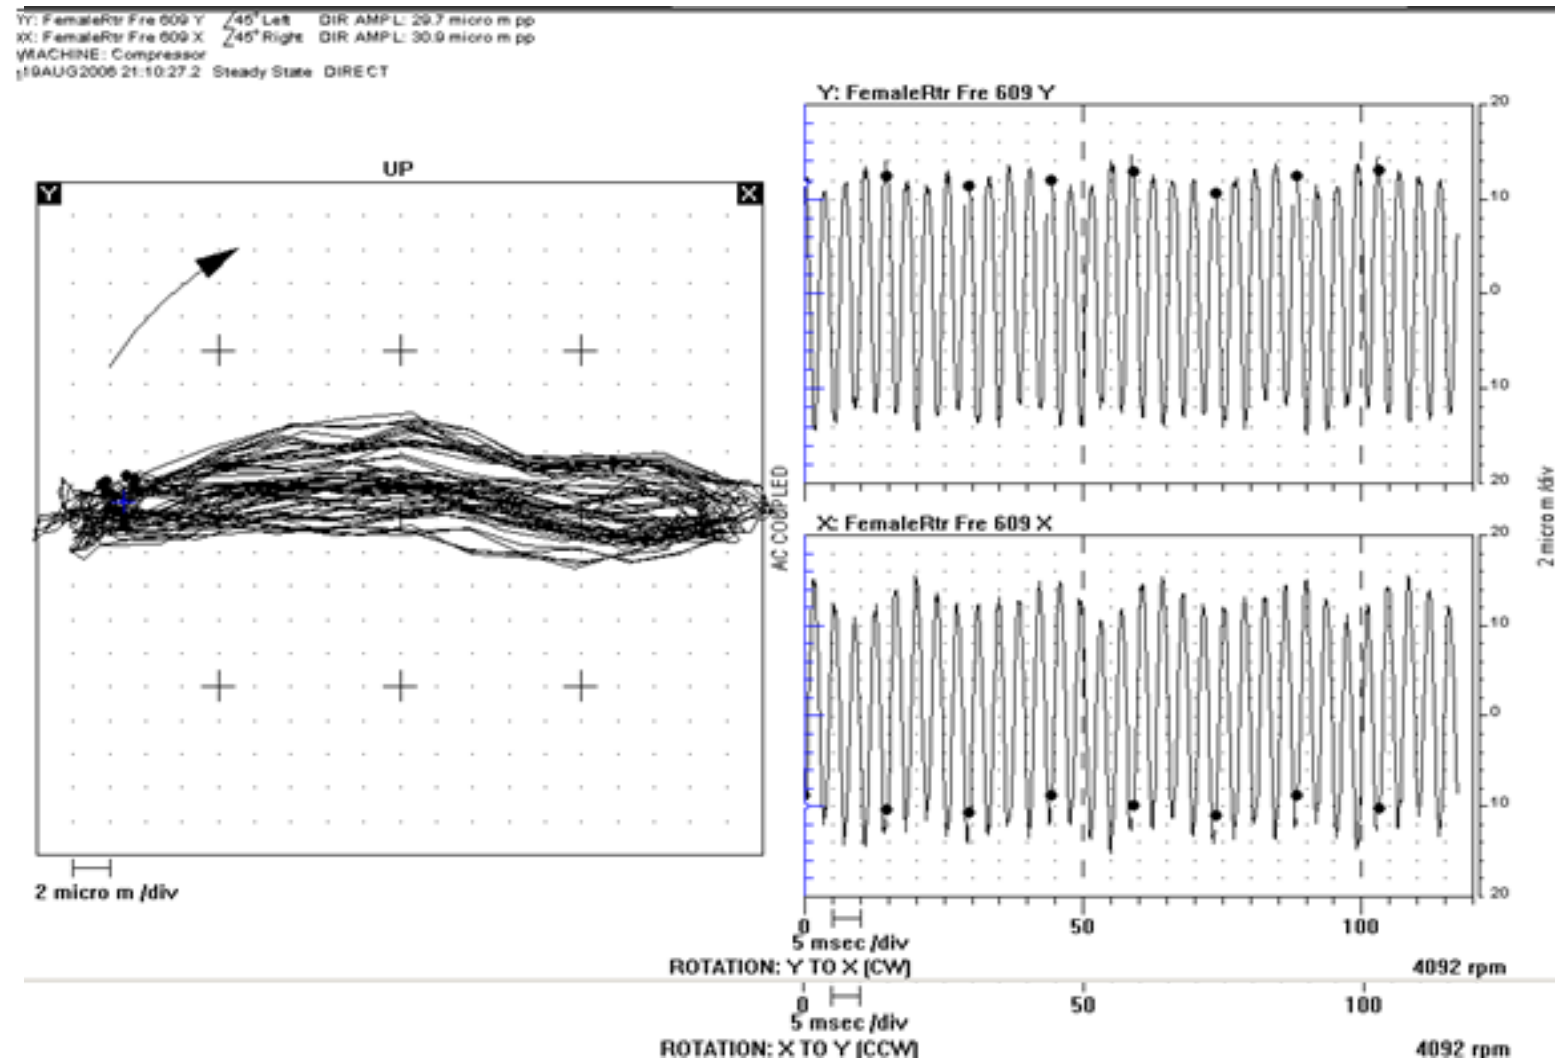
Compressor Vibration Before Failure

- 1X vibration of the male rotor free end was **3 μ m pp** and **negligible** on female free end during steady state operation with recycle valve fully closed
- 4X component dominated the frequency response of male and female rotors
- Presence of first harmonic of 4X component in the spectra
- 4X frequency is related to the 4 lobes on male rotor

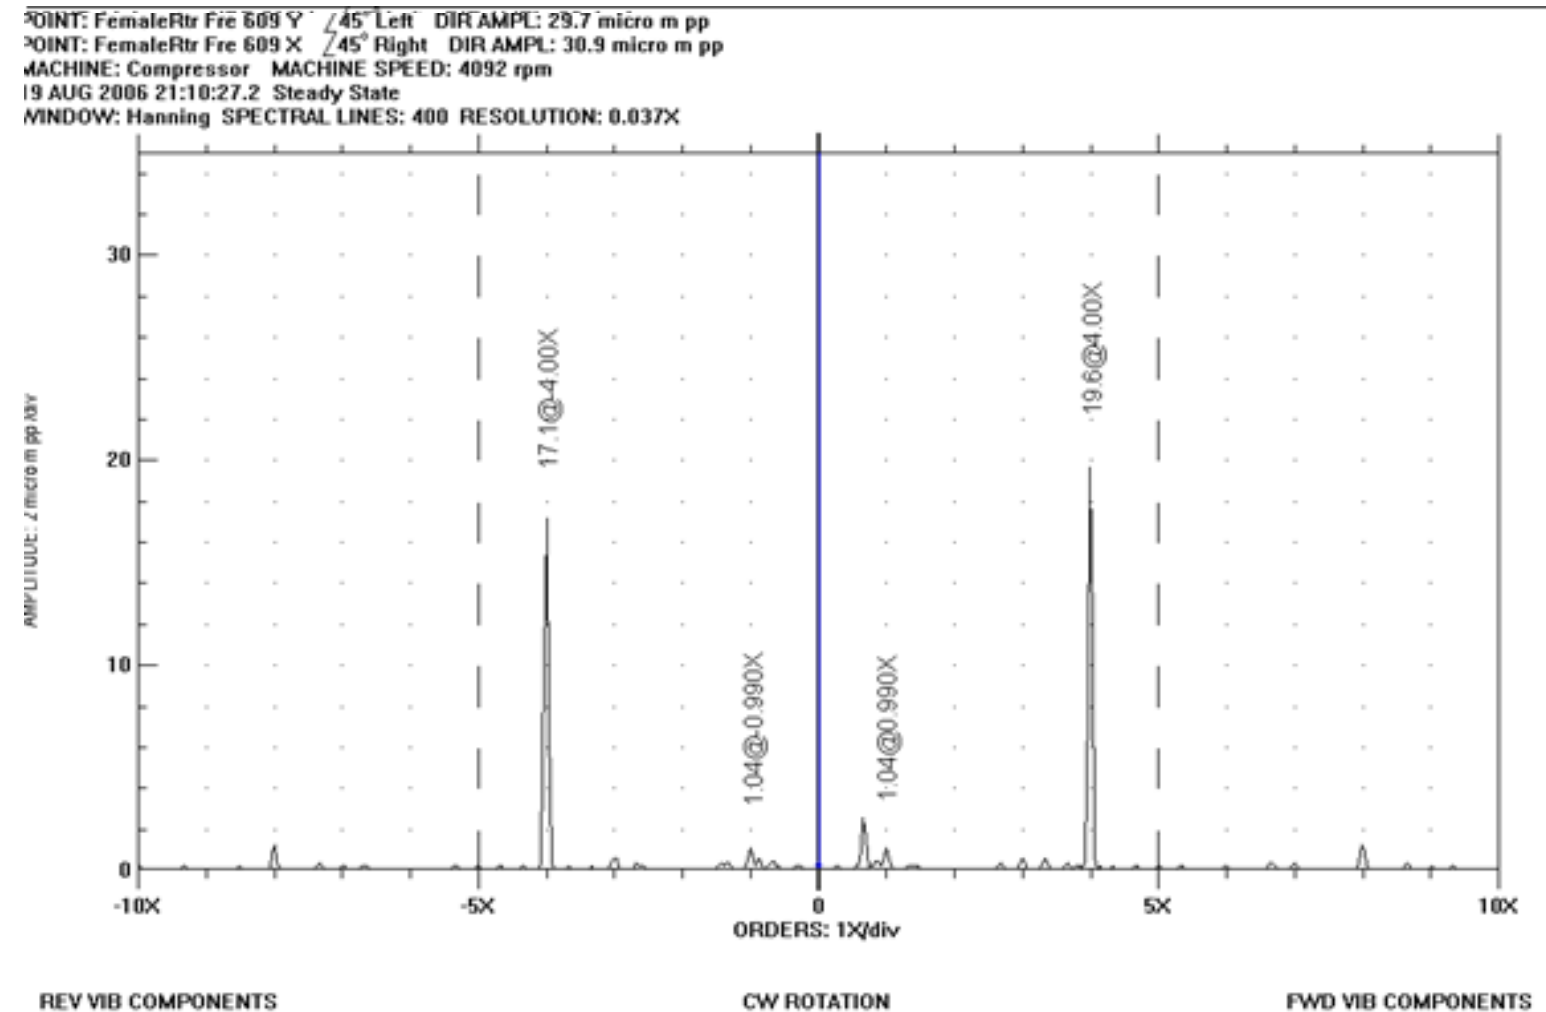
Compressor Startup Data After Seals Replacement

Unusual Direct orbits and elliptical 1X - filtered orbits of male and female free ends at same speed

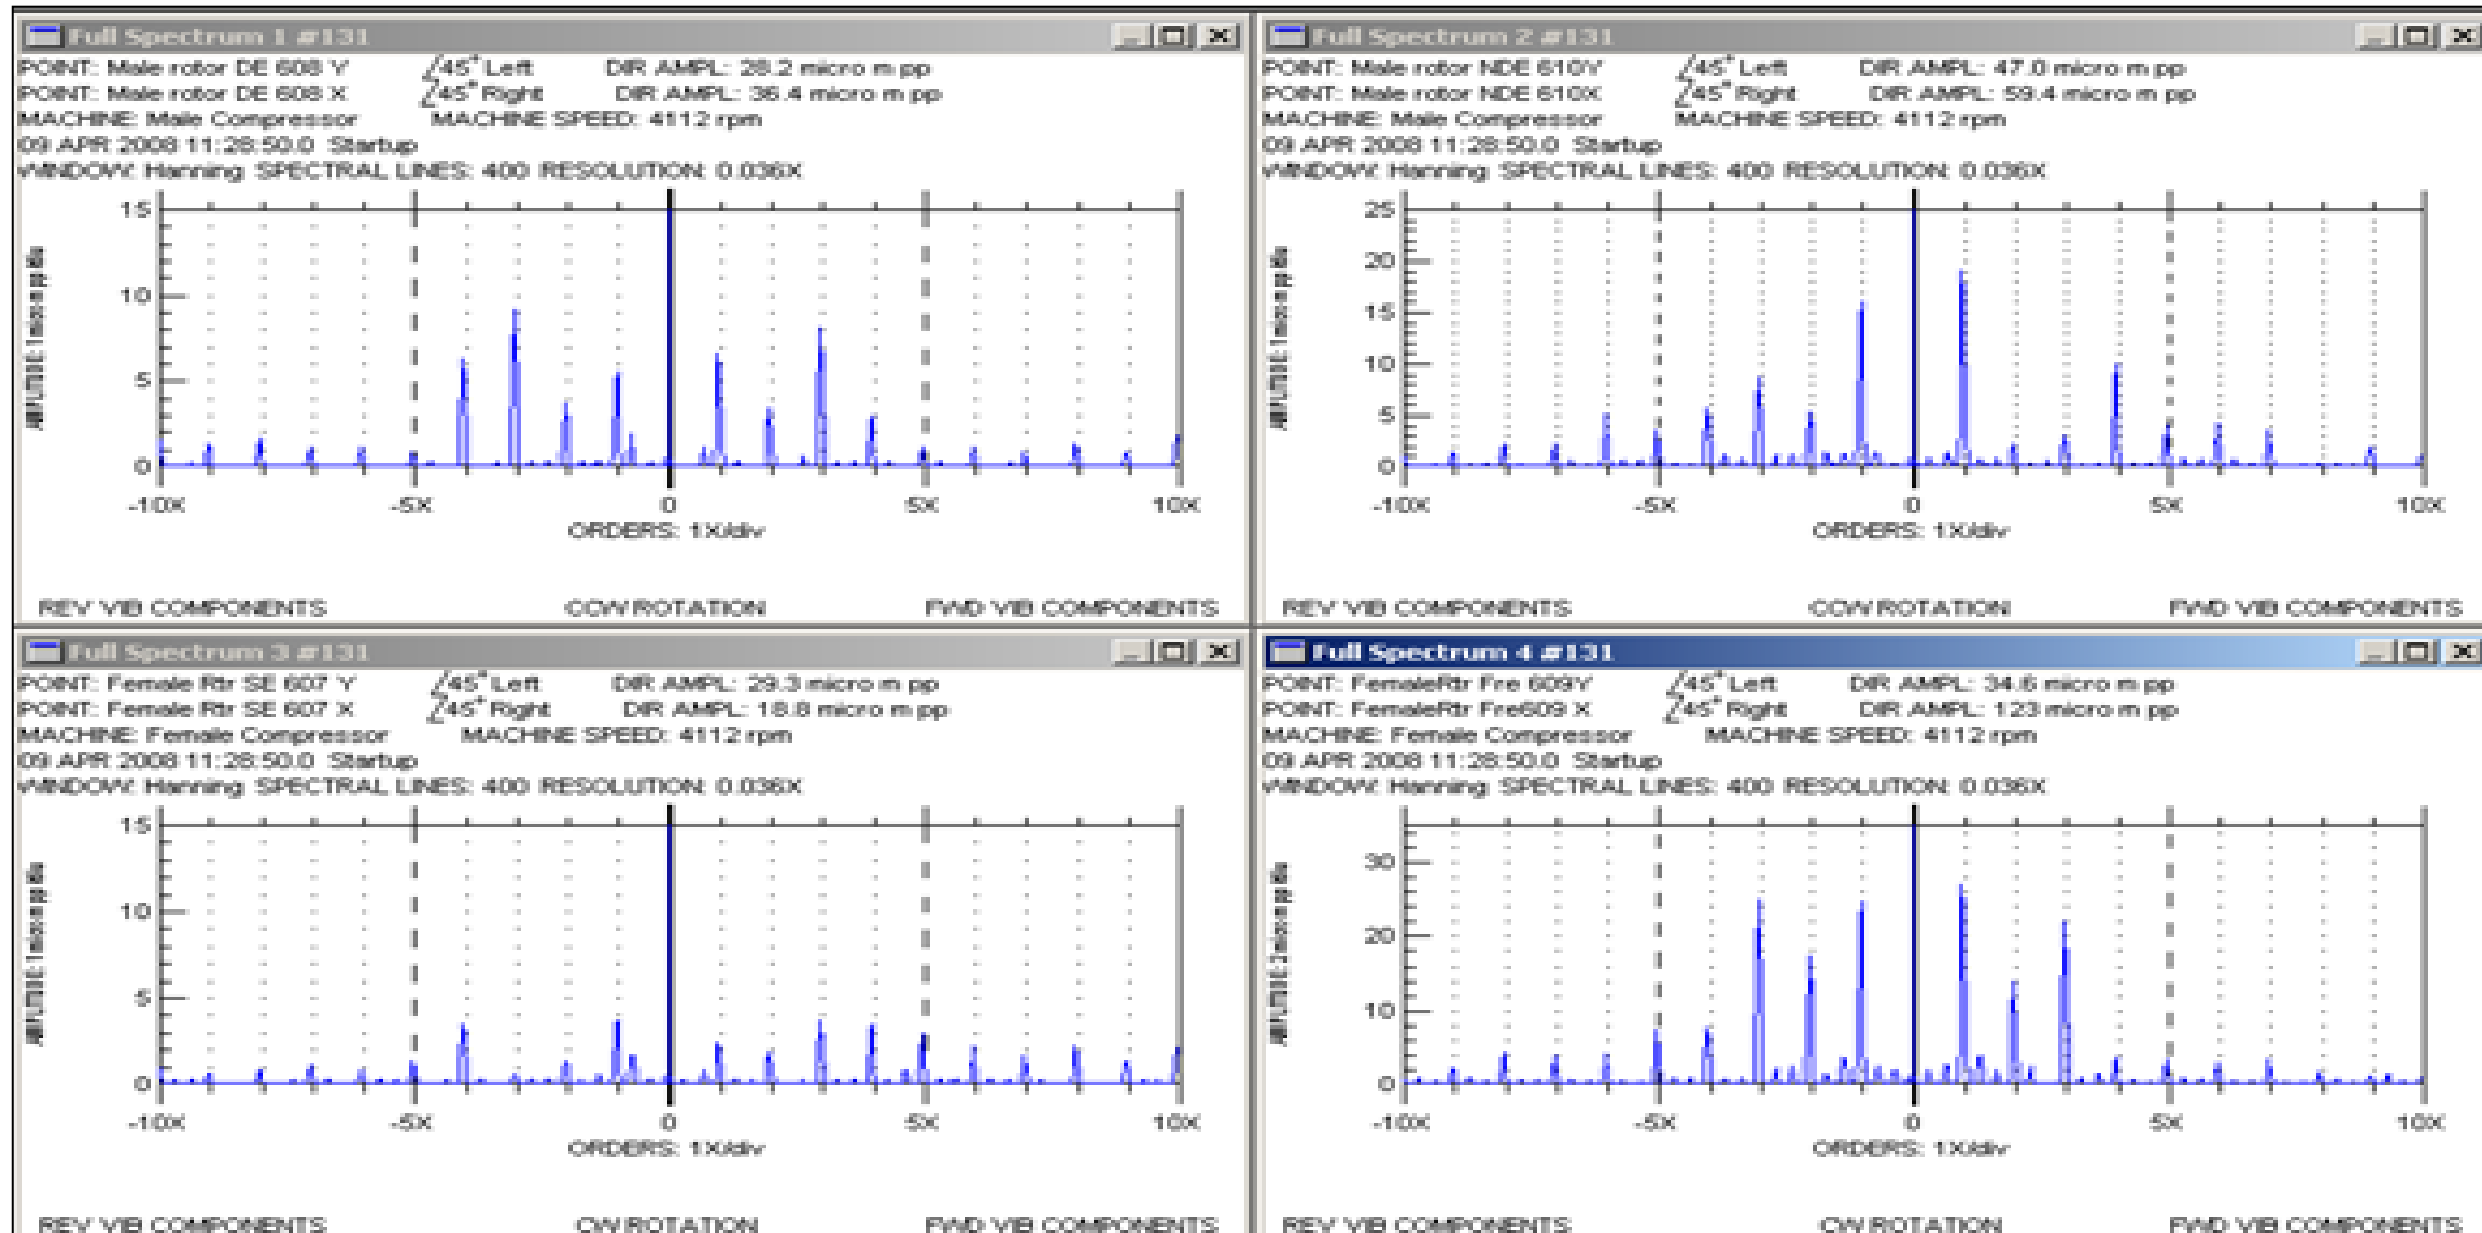
The full spectra analysis show significant vibration levels with similar amplitude for forward and reverse precession components, an indication of rub

- Amplitudes of lobe pass frequency (4x component) decreased on female rotor, suggesting changes in lobe tip clearances. Presence of running speed harmonics with forward and reverse precession at harmonic frequencies on male and female rotors
- Significant reverse precession for all harmonics on male and female rotors

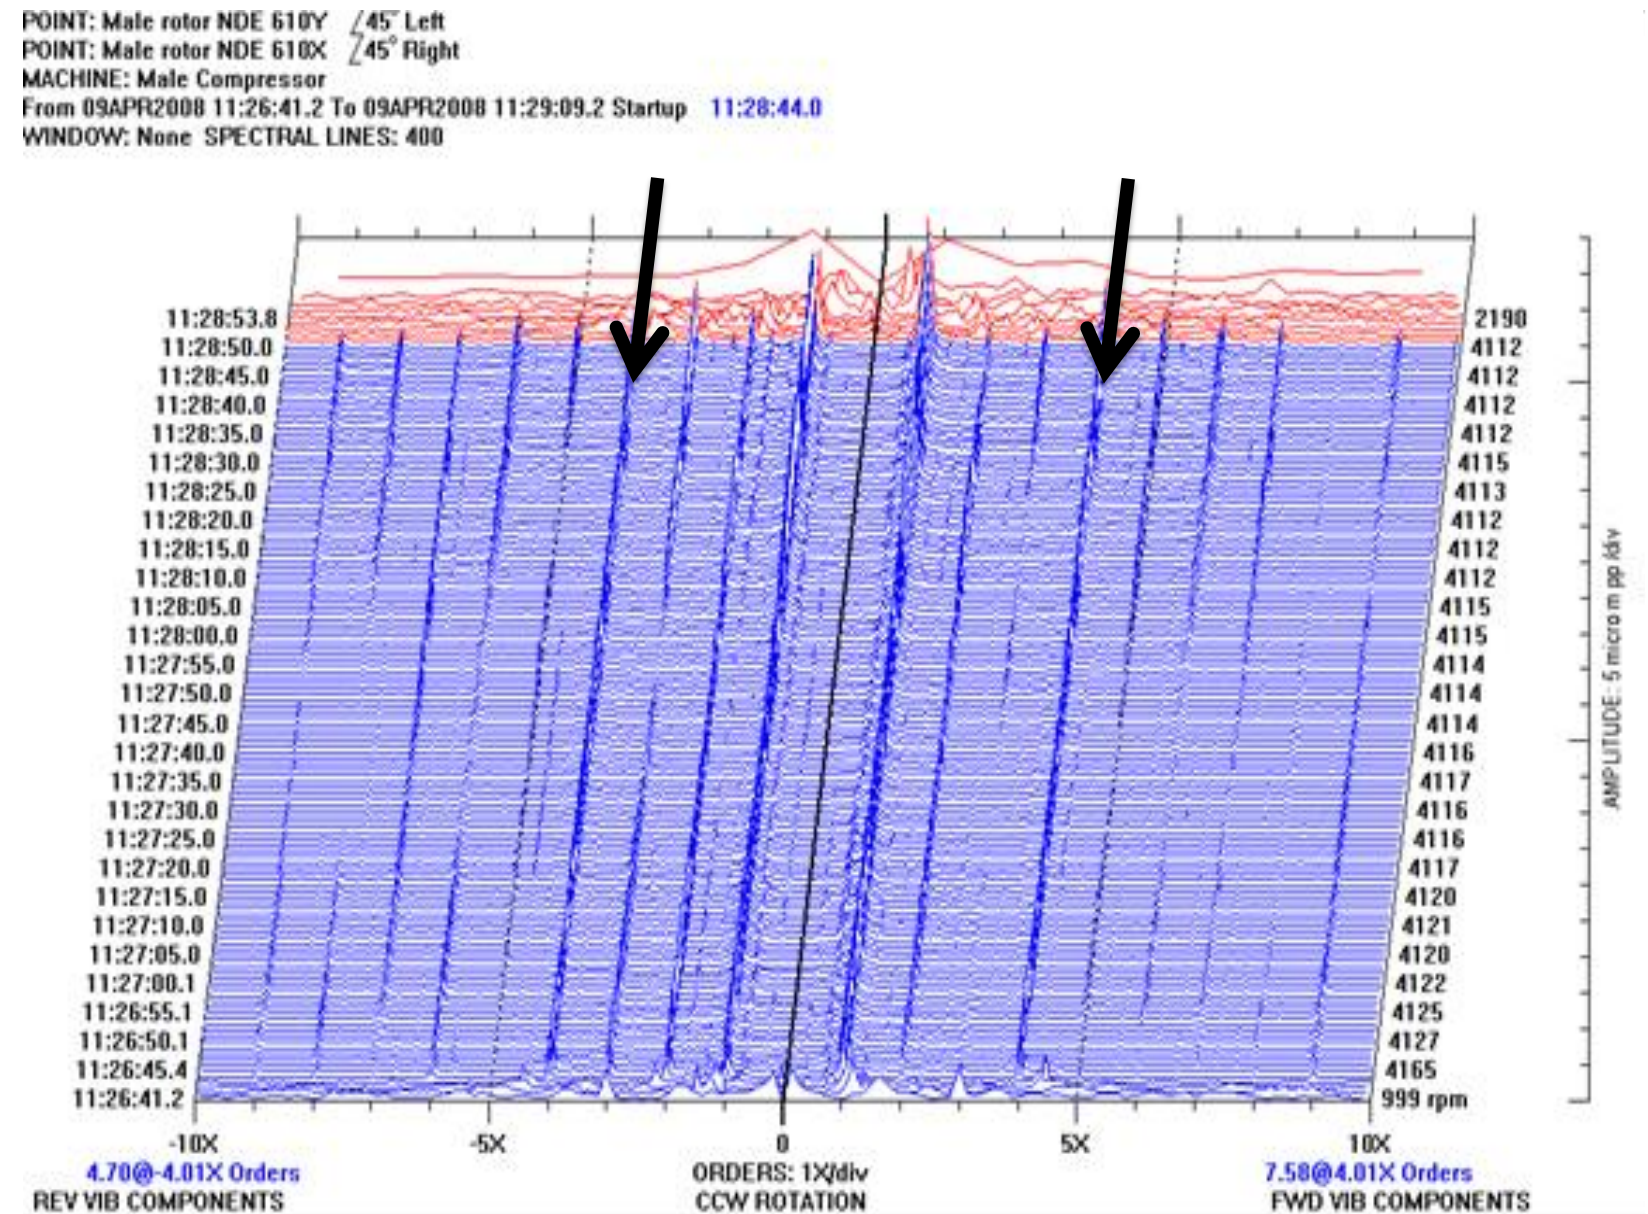
Data Analysis

- Direct and 1X amplitudes increased considerably at operating speed and was accompanied with unusual noise
- Overall amplitude reached over 100µm pp at operating speed of 4100rpm on female free end
- Considerable difference exist between 1X-filtered and direct amplitudes during run down compare to run up, indicating the dominance of other frequencies

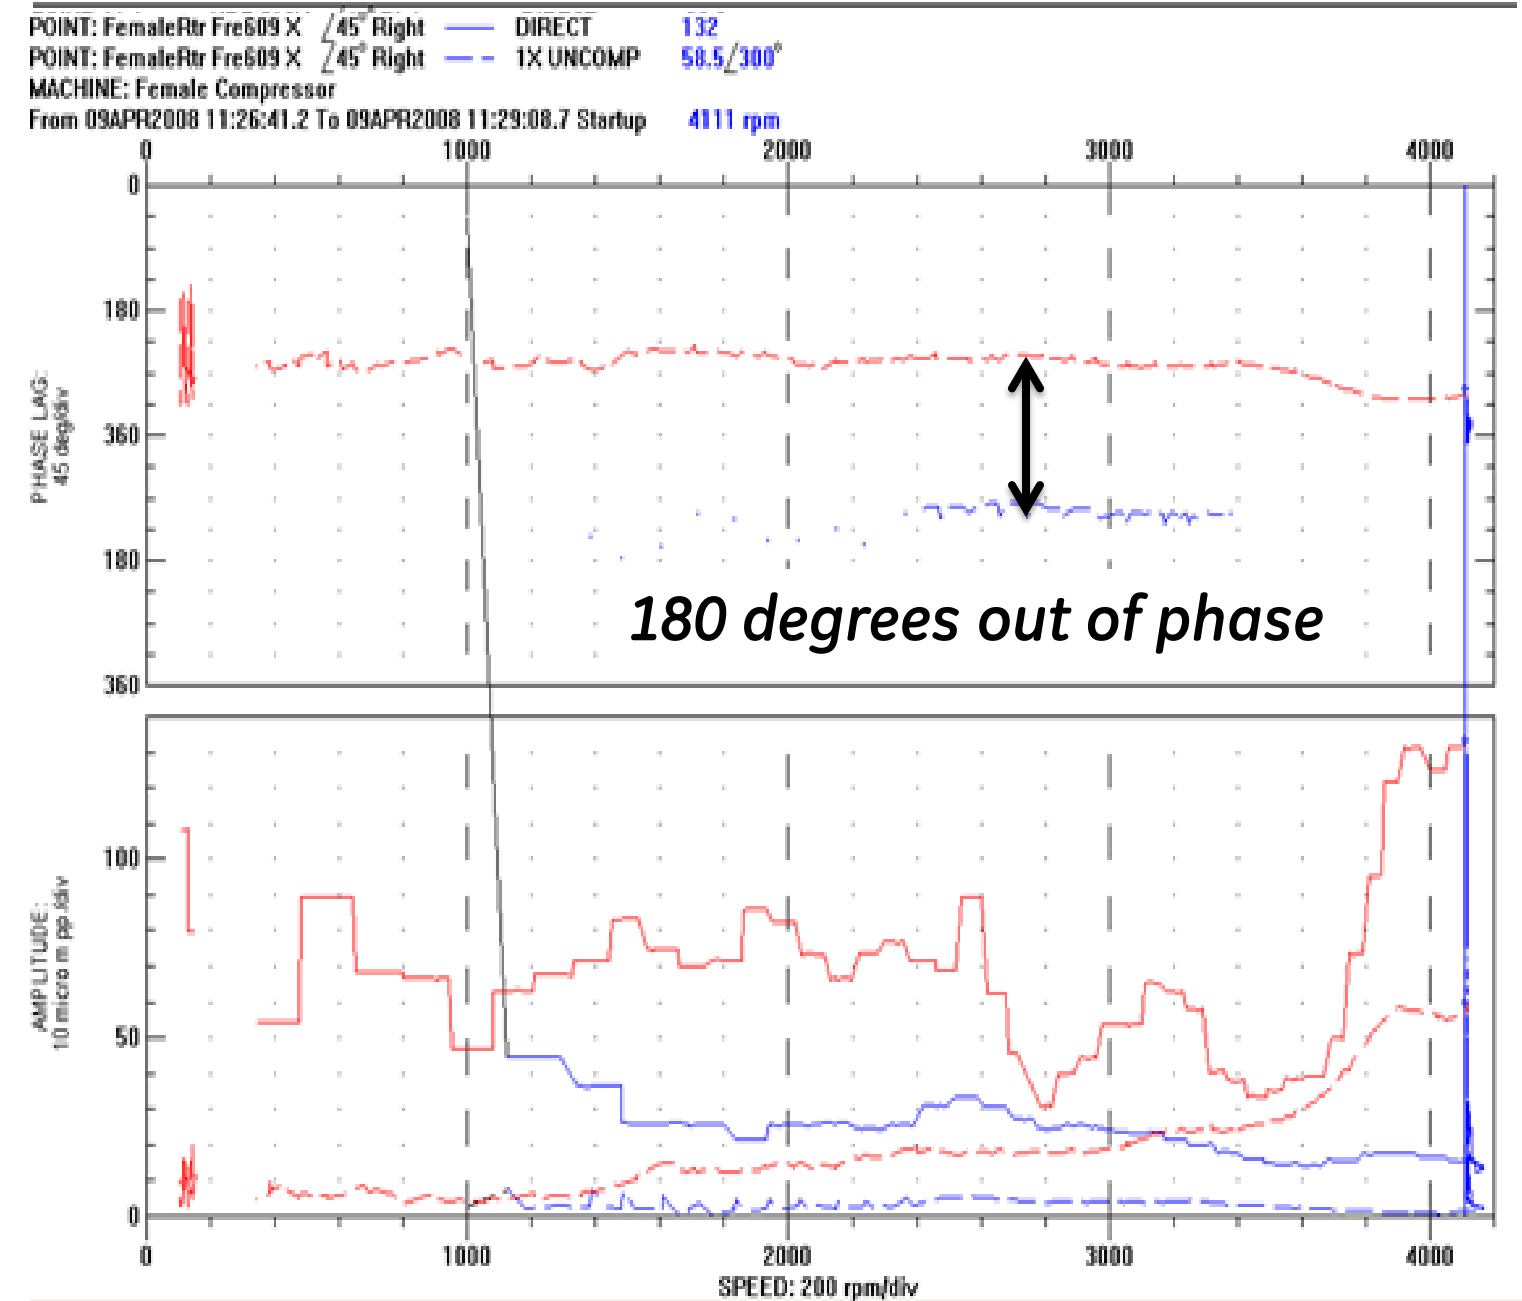
Data Analysis

- Shutdown data shows that high overall and 1X vibration amplitudes were sustained within 3800 - 4100rpm before decreasing with speed
- Coast down data of male rotor free end shows high direct vibration amplitudes compared to startup data due to excitation of 1X harmonics caused by rub
- 180 degrees out-of phase between shutdown and startup on female free end

Rub occurred between male and female rotors causing excitation of 1X harmonics

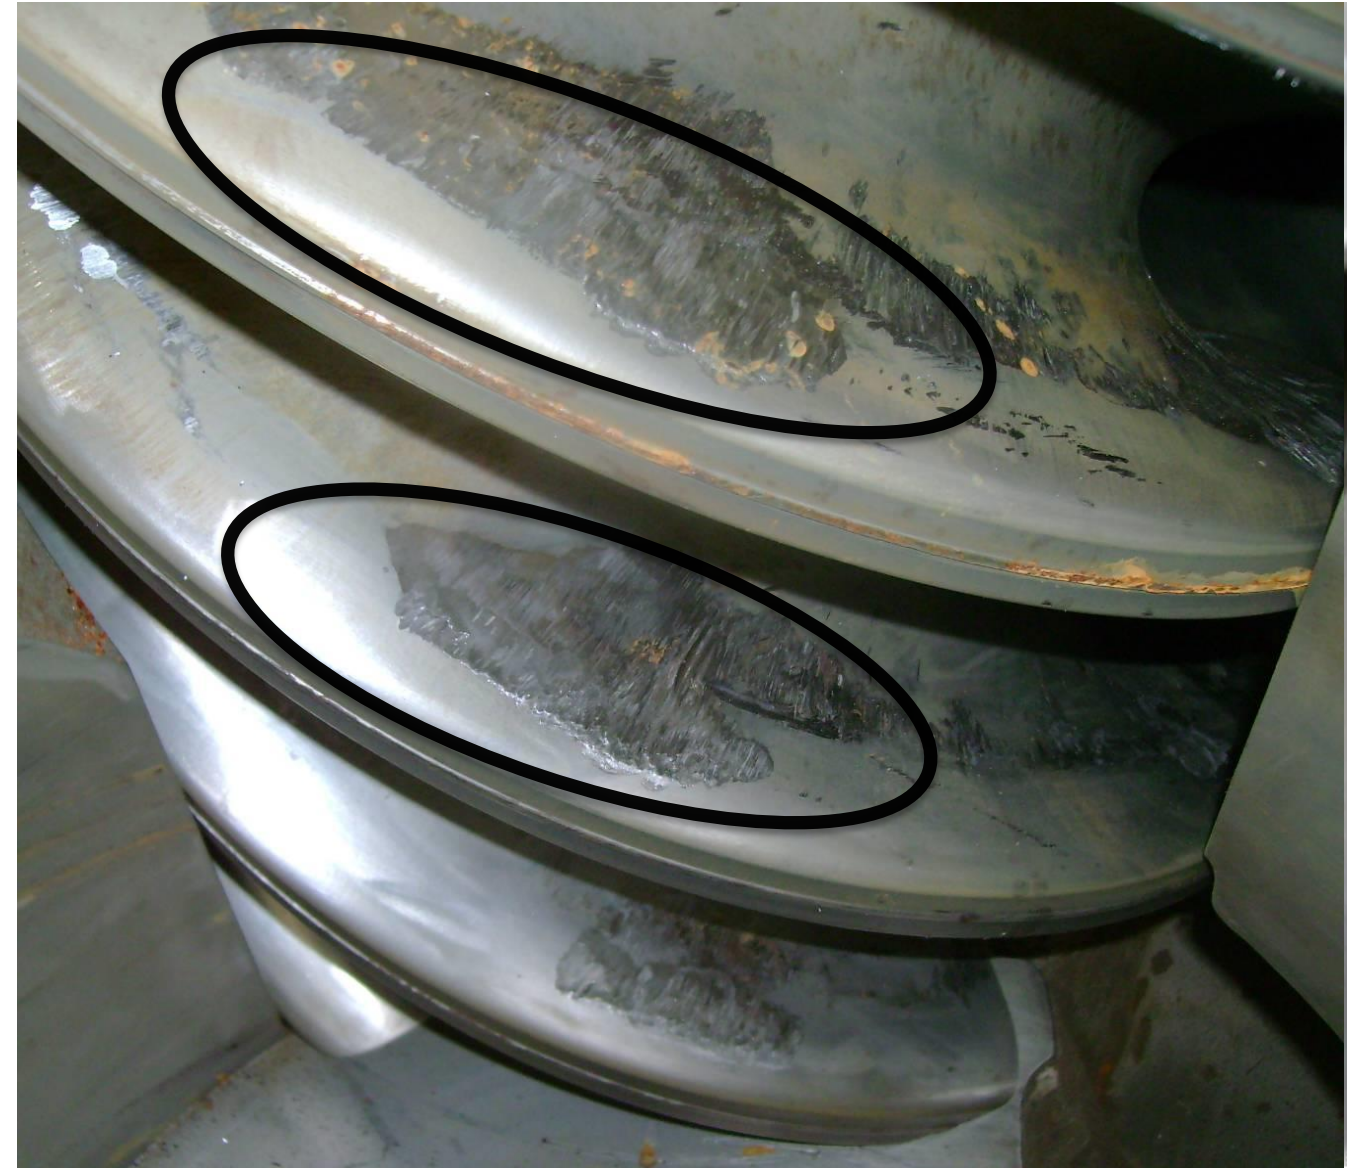
- Rotors were inspected for evidence of rub
 - Rubbing marks were found on both male and female rotors
- Timing gears on rotor free-end were inspected
 - Timing gears discovered to be improperly set up
 - The splitter inserted in discharge-end cover to achieve gear lubrication and cooling was inspected and confirmed corroded and blocked
 - Reduced oil supply to the helical gears

Extent of rub on male and female rotors prior to removal

- The conditions of the timing gears were found satisfactory during inspection, they were reused and set up correctly
- The blocked and corroded splitter in discharge end cover was replaced
- Male and female rotors were cleaned and dressed
- Runout check confirmed slight out of roundness of male rotor and it was polished
- Trim balancing was performed at low speed
- End-user contacted seal supplier to discuss permanent fix to the problem of frequent seals contamination
- Compressor started successfully and overall vibration of male and female rotors' free end reduced considerably to 21 μ m pp and 17 μ m pp respectively during steady state operation after the correctional changes.

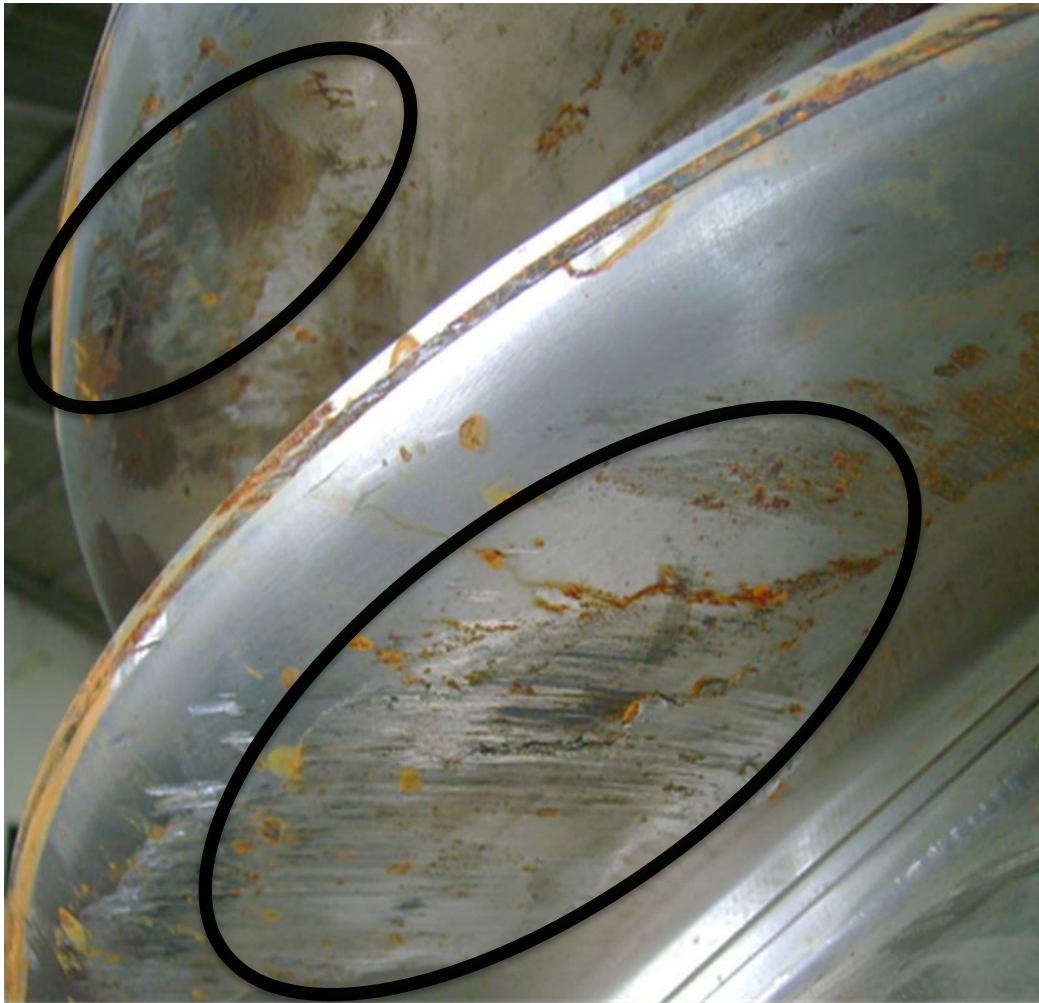
Male rotor

Areas of contact between male and female impeller lobes

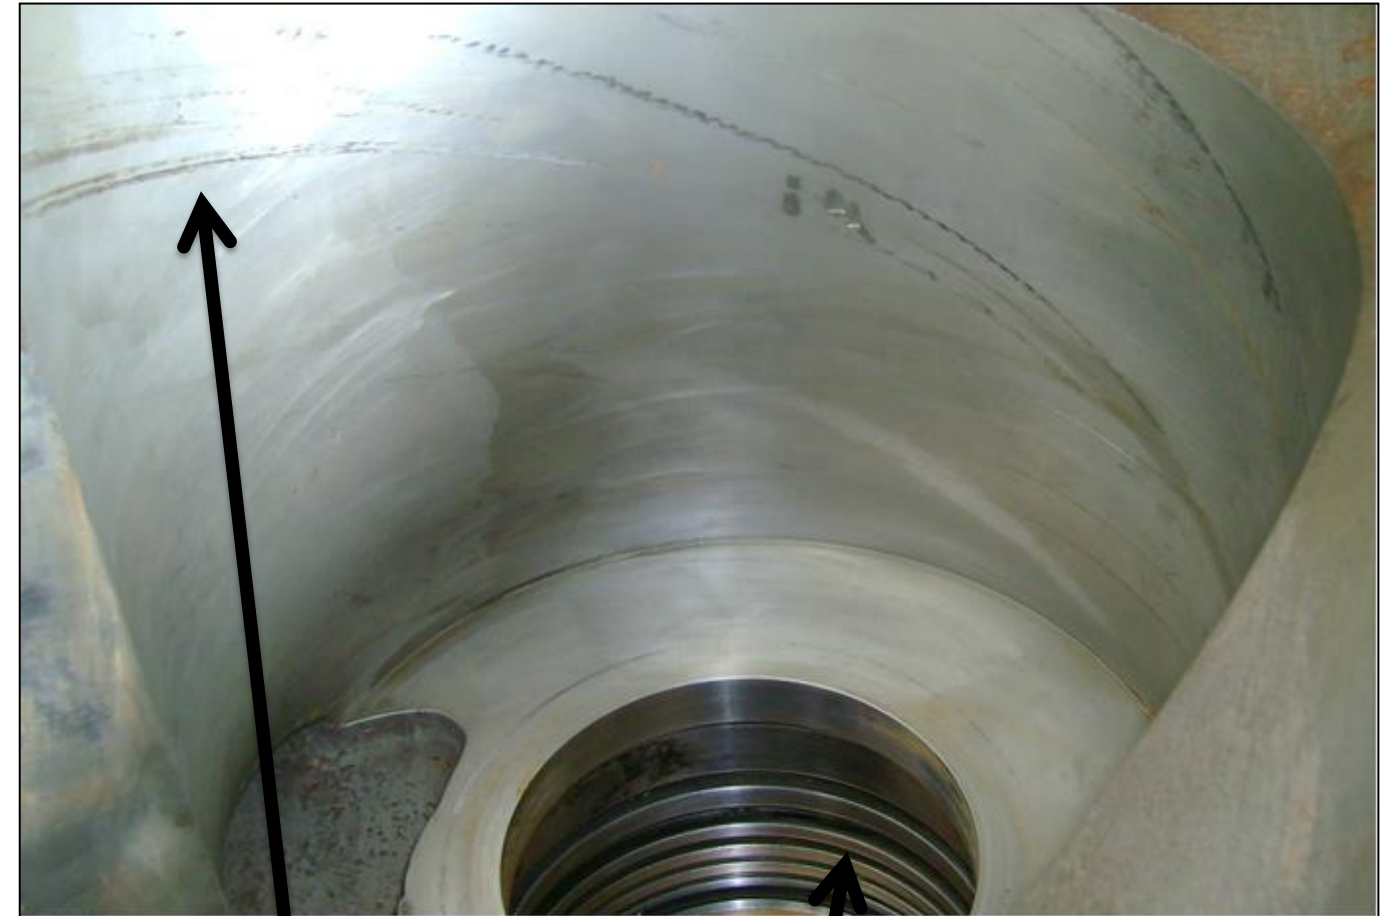
Minor damage to Rotor housing

Male rotor housing
showing damage areas
